MARYLAND HISTORICAL TRUST

Survey No. WA-I-497
MAGI No.
22514975604
DOE __yes _X no

INVENTORY FORM FOR STATE HISTORIC SITES SURVEY

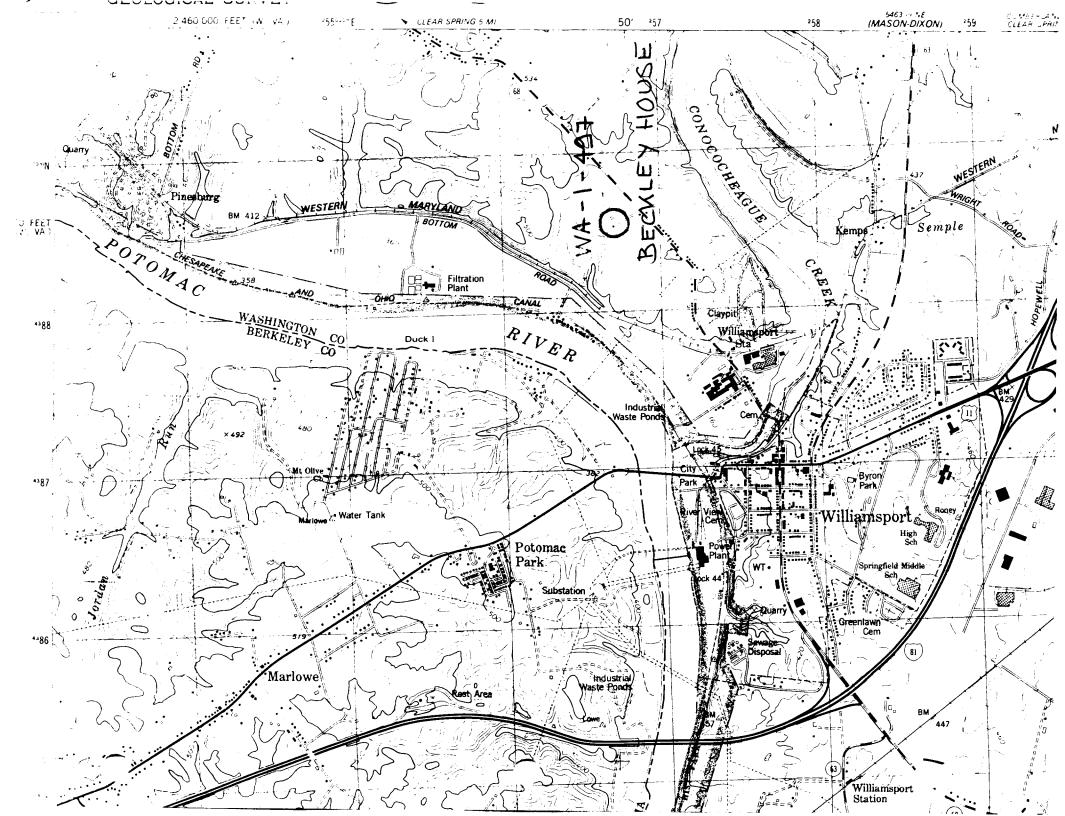
This building which has been damaged by fire, is located at the end of a dirt road from the south side of Route 68, north of Williamsport. It is composed of an (east) main block $1\frac{1}{2}$ stories in height and a two-story ell on the rear. Both sections are gable roofed and have German siding.

The east block is of log construction, partially exposed by fire damage, and has two end chimneys. It is four bays wide by two deep. The second floor (half story) windows on the principal facade are much smaller in size than those on the first floor. Most window sash on the main block are missing.
